**NASA
Technical
Paper
2190**

Crash Tests of Three Identical Low-Wing Single-Engine Airplanes

**Claude B. Castle
and Emilio Alfaro-Bou**

**Claude B. Castle
and Emilio Alfaro-Bou**
*Langley Research Center
Hampton, Virginia*

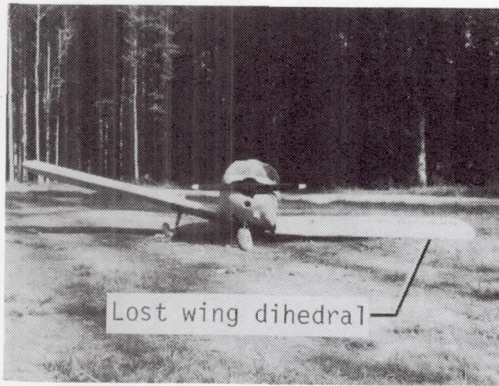
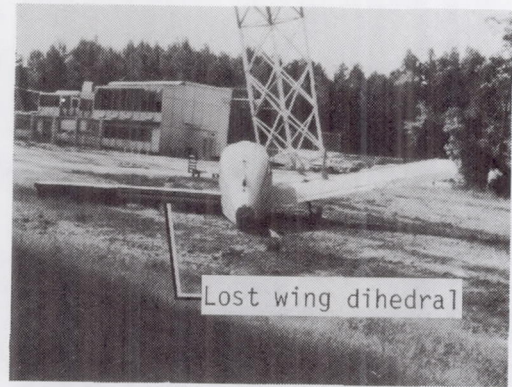
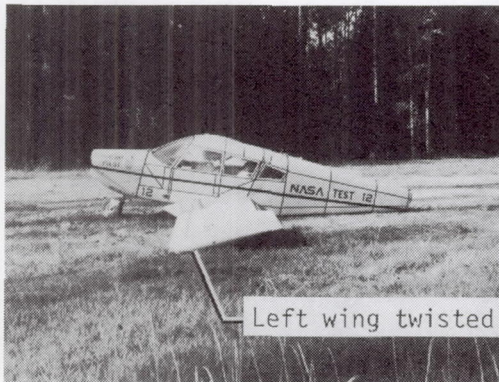
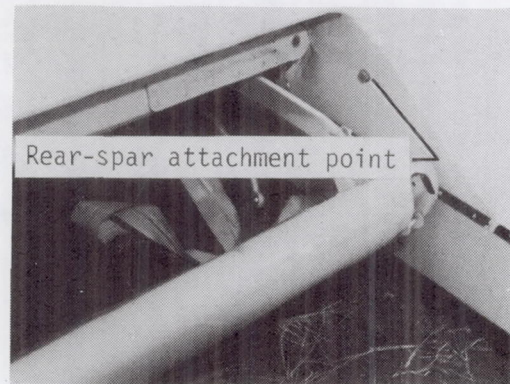
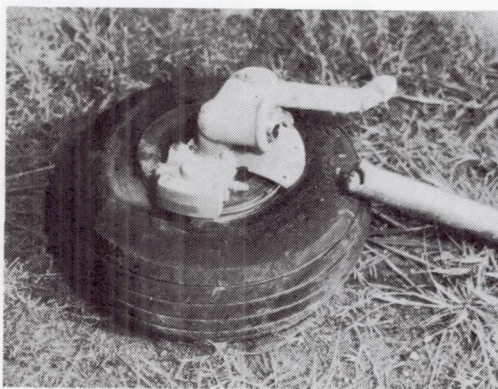
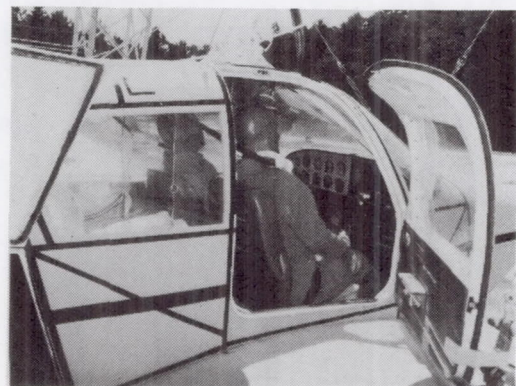
Figure 10.- Postcrash external damage to test specimen in 10° test on concrete (hard landing).

Assessment of damage.— Postcrash photographs of the external damage sustained by the airplane test specimen are presented in figure 10. The livable cabin volume (a volume sufficient in size to maintain space between the occupants and the structure) was maintained during the crash impact. In figure 10(a), the airplane is shown resting on its left wing, right landing gear, and nose wheel. All three tires experienced a blowout. The nose-gear fork bent and twisted as shown in figures 10(a) and (c). The twisted left wing, with no dihedral, the broken linkage for the inboard flap, the sheared rear-spar attachment bolt, and the sheared fore-wing attachment to the fuselage are shown in figures 10(a), (b), (c), and (d), respectively. The fuselage is shown to be in good overall condition except for a slight deformation at the interface with the inboard left-wing flap. Figure 10(e) shows the damaged left land-

ing gear with the fractured shock absorber. Figure 10(f) shows the crew compartment, the pilot and copilot dummies, and their restraints. The overall lack of structural damage by this test is also shown in figure 10(f).

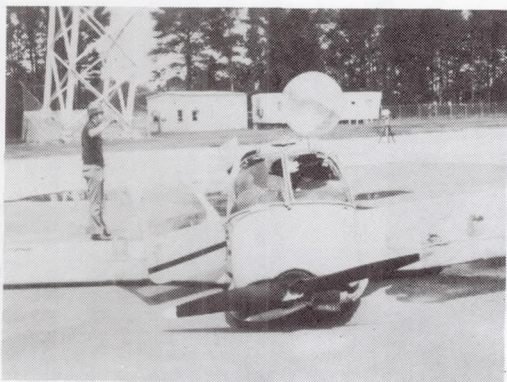
(a) Overall view from front.

Assessment of damage.- Postcrash photographs of the damage sustained by the airplane specimen are shown in figure 12. Figure 12(a) shows the airplane in its final position resting on the fuselage and wings. The nose and main landing gears fractured and collapsed and the tires blew out during the impact. Both windshields broke and the center post between the windshields bent. Some of the front damage can be seen under the engine cowling. The impact force caused part of the lower fire wall to protrude about 20 cm into the cabin. Both wings lost their dihedral, and the left wing is shown propped by the collapsed landing gear. The balloon seen in figure 12(a) was part of an Emergency Locator Transducer (ELT) experiment for locating a crashed airplane by visible means.

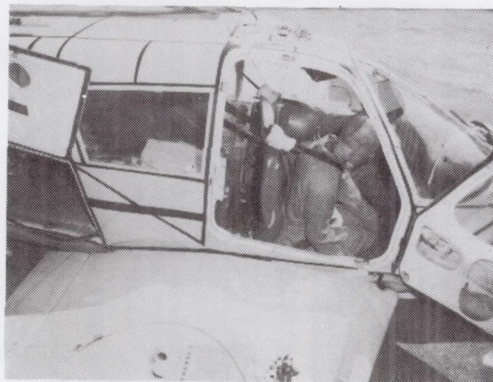
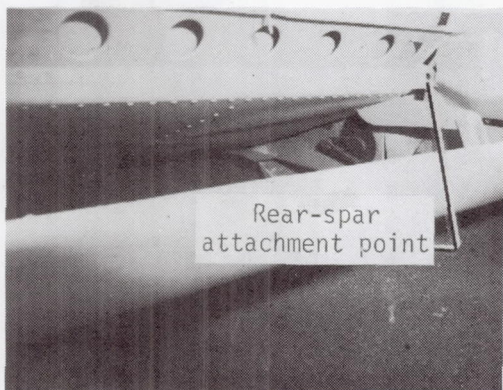
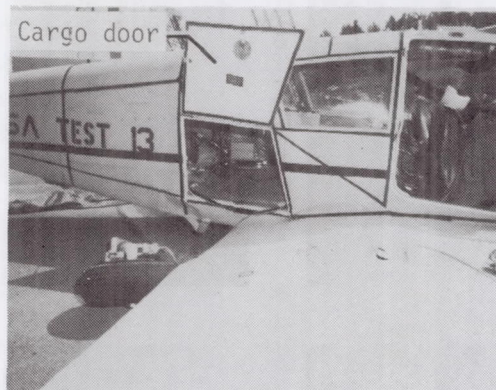
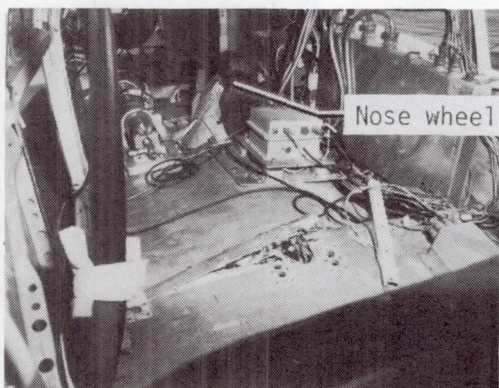
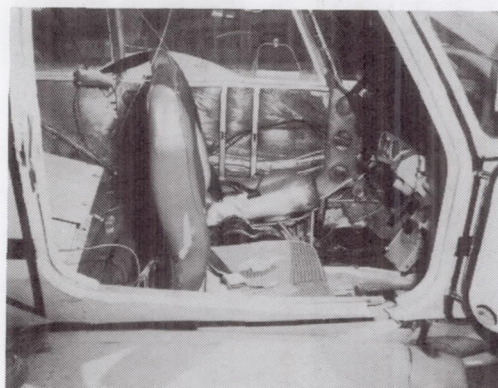
Figure 12.- Postcrash damage to test specimen in -30° (nose-down) test on concrete.

Figure 12(b) shows the pilot and copilot dummies restrained to their seats after the airplane came to a stop. Also shown is buckling of the airplane nose and side panel over the wing. The space between the seats and instrument panel, as well as the livable cabin volume, was maintained. Figure 12(c) shows the left inboard-flap control broken, the rear-spar attachment pin sheared off, and some buckling in the fuselage skin. Figure 12(d) shows a collapsed landing gear and buckling of the skin under and aft of the cargo door. In figure 12(e), the nose wheel is seen embedded in the floor of the rear cabin. Also shown is the rear-cabin-floor upheaval aft of the passenger compartment, the transducer junction box, and the pyrotechnic programmer box. Figure 12(f) shows a slight deformation in the aft member of the doorframe and a fracture in the lower front corner. Other damage to the airplane, not shown in these photographs, was buckled skin from the airplane nose to the third left window, a buckled wing at the attachment point to the fuselage forward of the main spar, a cracked first-passenger window, a collapsed left landing gear, and a failed copilot seat rail at the rear-legs attachment point.

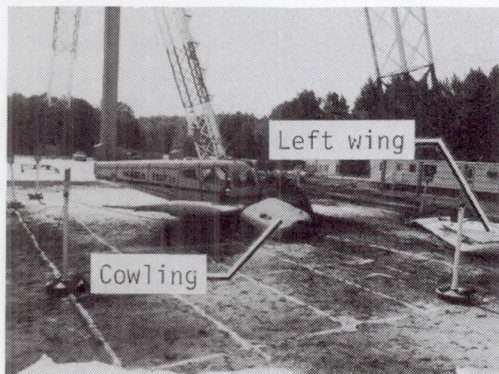
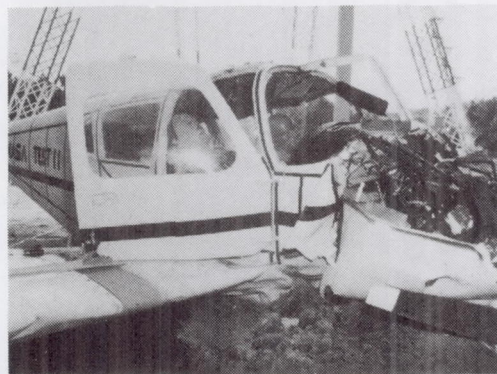
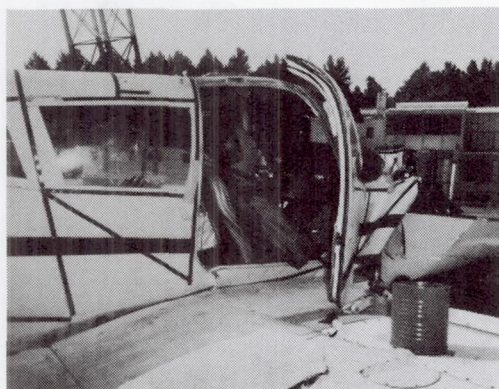
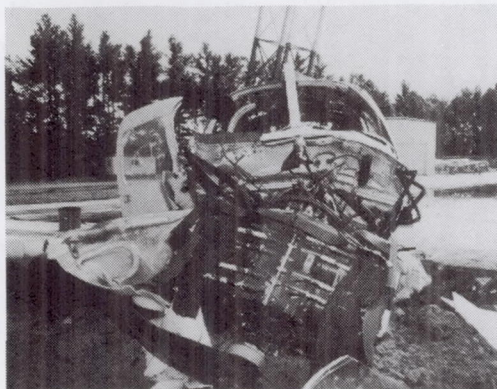
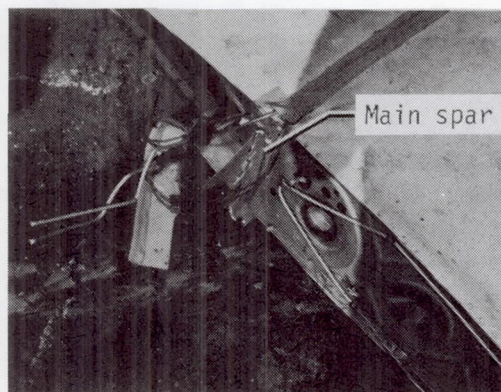
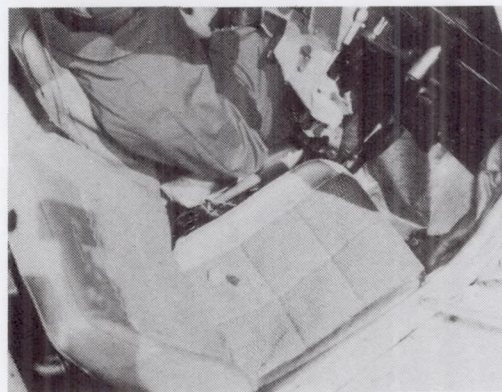
Figure 14.- Postcrash damage to test specimen in -30° (nose-down) test on soil.

Assessment of damage.— Postcrash photographs of the damage sustained by the airplane specimen are shown in figure 14. The livable cabin volume, although reduced, was maintained during the crash impact. Figure 14(a) shows the airplane in its final position resting on the fuselage and right wing. The left wing is shown detached and in front of the airplane. The engine top cowling has come off and is shown on the right side ahead of the wing. Figure 14(b) shows buckles on the wing leading edge and on the side panel ahead of the door, and also shows damage to the nose, windshields, and center post of the airplane. The degree of center-post bend is an indication of the protrusion of the fire wall into the cabin. The protrusion of the lower half of the fire wall into the cabin measured up to 51 cm and was more severe than the top half. Figure 14(c) shows a tear on the wing over the landing gear, separation of the right wing from the fuselage aft of the main spar, a fracture in the lower rear of the doorframe, and the copilot-dummy's knees bent up due to the reduced space from the seat to the fire wall. Figure 14(d) shows a bent propeller, a bent and fractured engine mount, a torn lower engine cowling, and a deformed fire wall. Figure 14(e) shows a fractured main-spar attachment to the wing and the broken hydraulic lines in the left wing. Figure 14(f) shows the floor and foot-control deformations in the copilot's side of the fuselage.
